4K Construction LLC

Your Property Inspection Report

123 Main St., Your Town 12345
Inspection prepared for: Sample Report
Date of Inspection: 2/12/2014 Time: 1:30
Age of Home: 2006 Size: 1800
Weather: Sunny 25 deg. F

Inspector: Kerry Louwagie
Contractor License #BC638118, NACHI ID# NACHI14011010
2374 60th Ave., Balaton, MN 56115
Phone: 507-828-5640
Email: wrangler84@hotmail.com

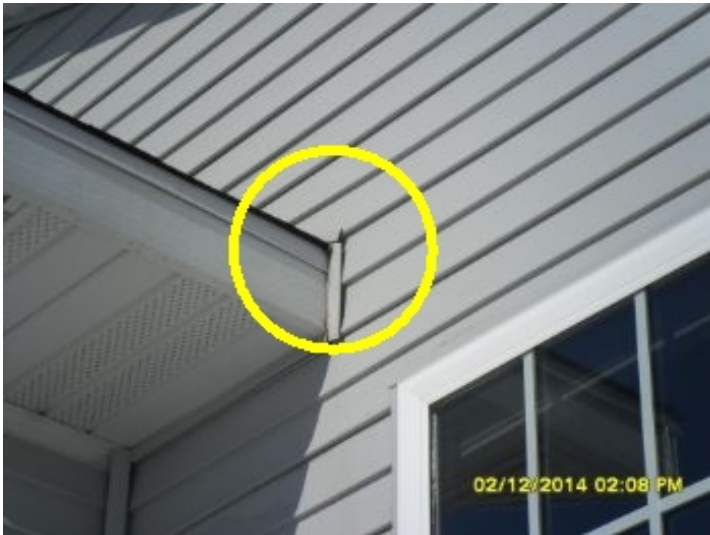
Flashing appears inadequate. No kick out flashing where eave meets the sidewall.

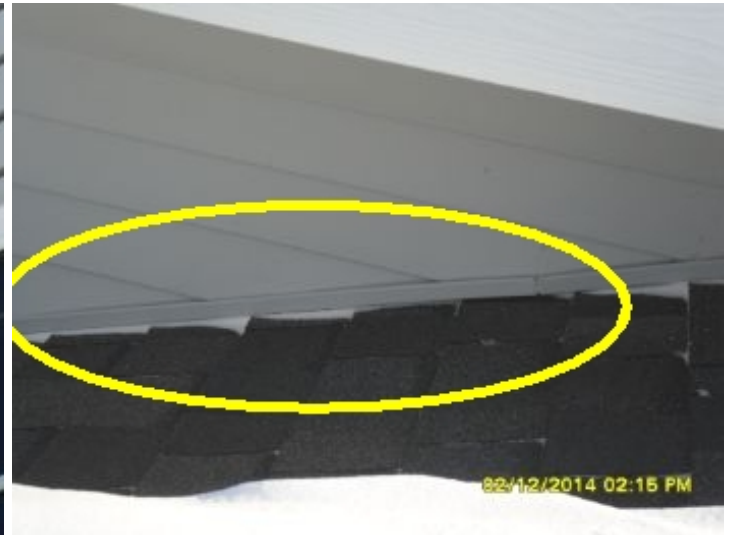
Siding-Roof Contact: Check for moisture damage. Recommend a 1" gap between the siding and the roofing where necessary. This may be the cause of possible moisture problems in the living room and bedroom.

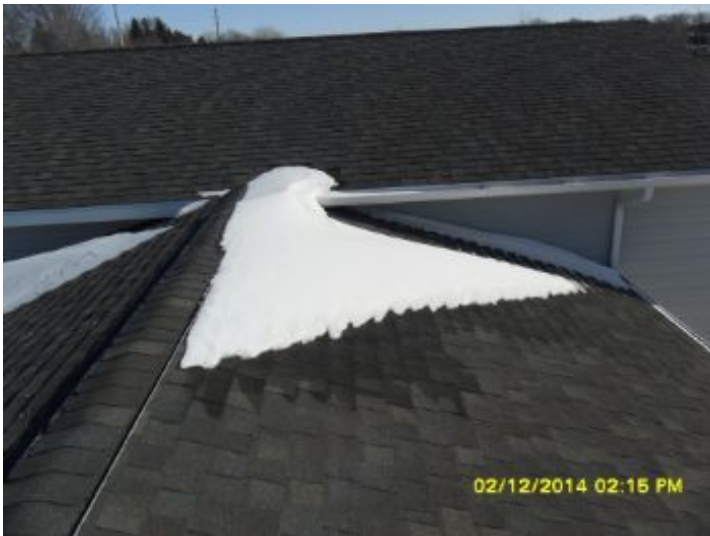
Snow covered; not fully inspected.

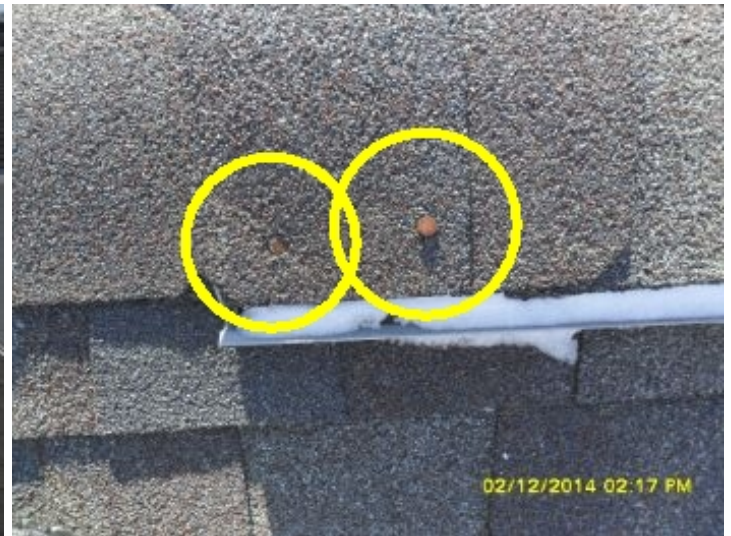
Ridge cap: Exposed nails are not sealed and are rusted.

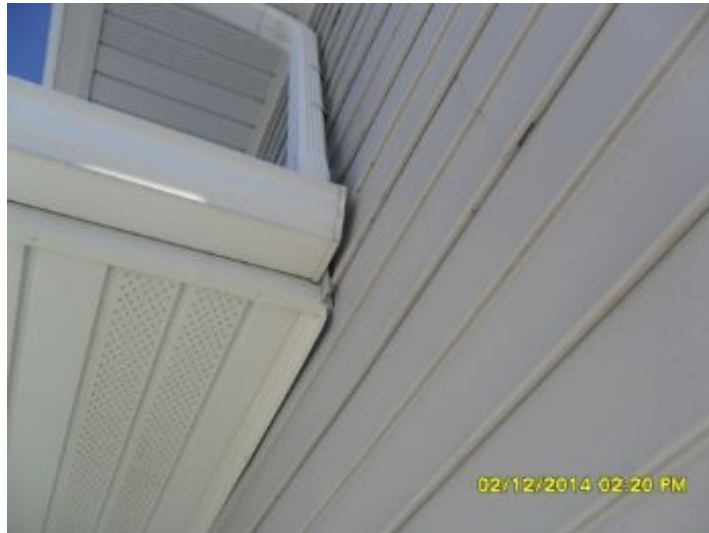
Flashing appears inadequate. No kick out flashing where eave meets the sidewall.

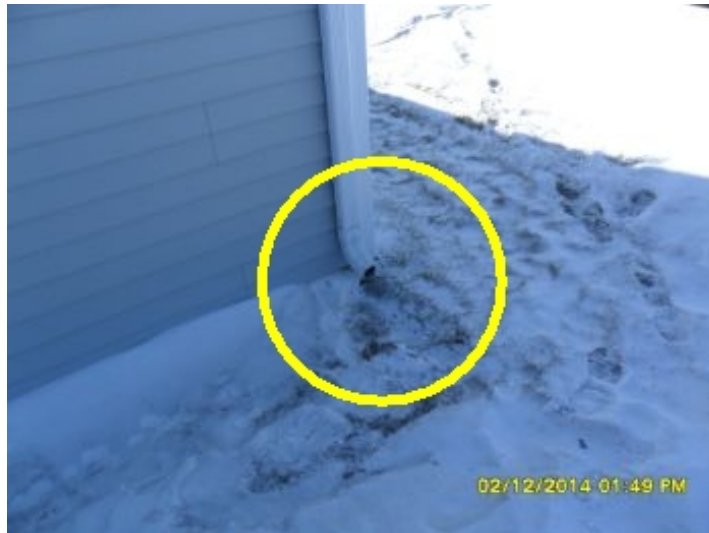
Extensions / Splash blocks missing or insufficient: Install to divert water away from the foundation.

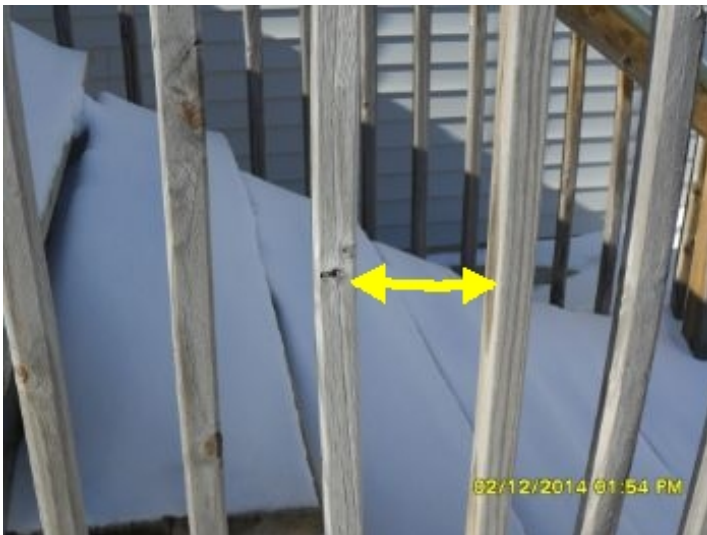
Spindle spacing exceeds the 4 inch spacing (due to spindle warpage) which is considered safe by today's child safety standards.

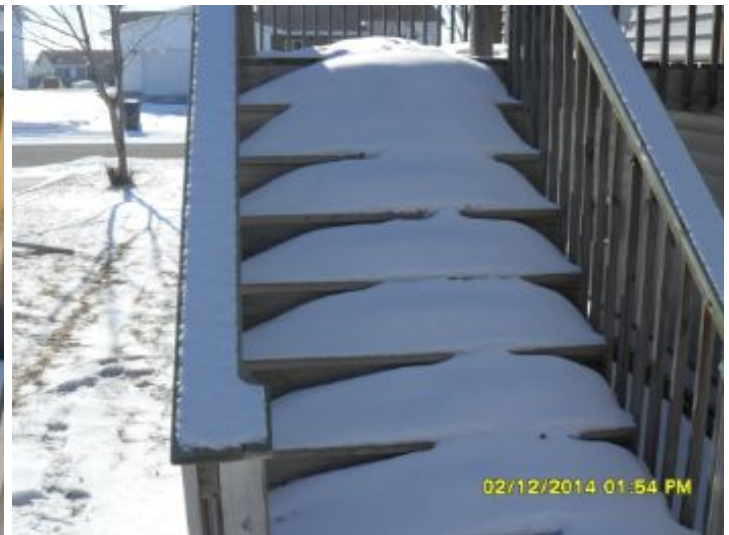
Snow covered; not fully inspected.

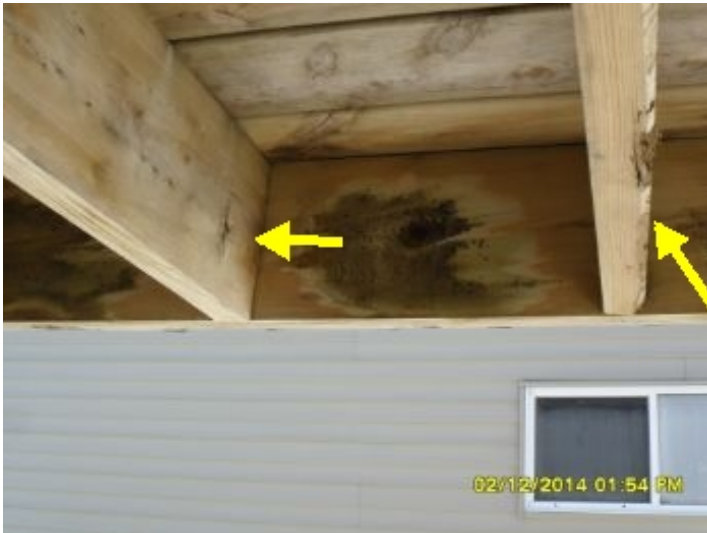
Deck installed without supporting bracket hardware. Recommend installing brackets.

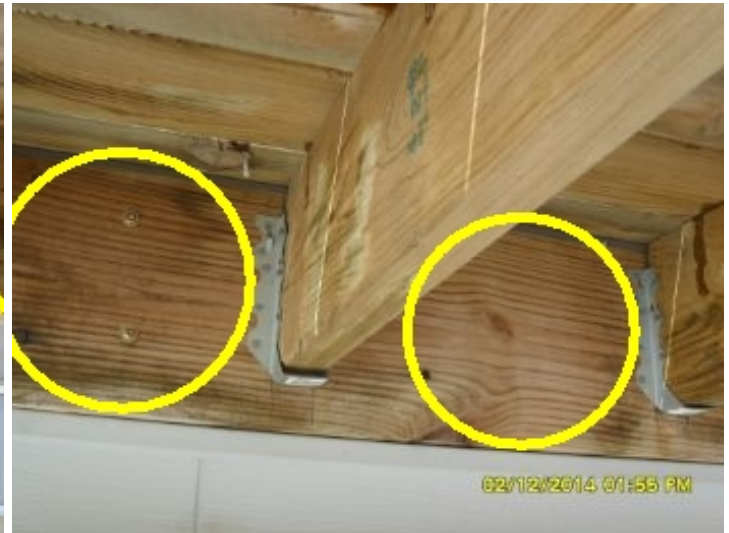
No Lag Bolts Visible: The deck ledger board is nailed or screwed to the house. Consider installing lag screws to securely attach ledger board to house, if they have not been used.

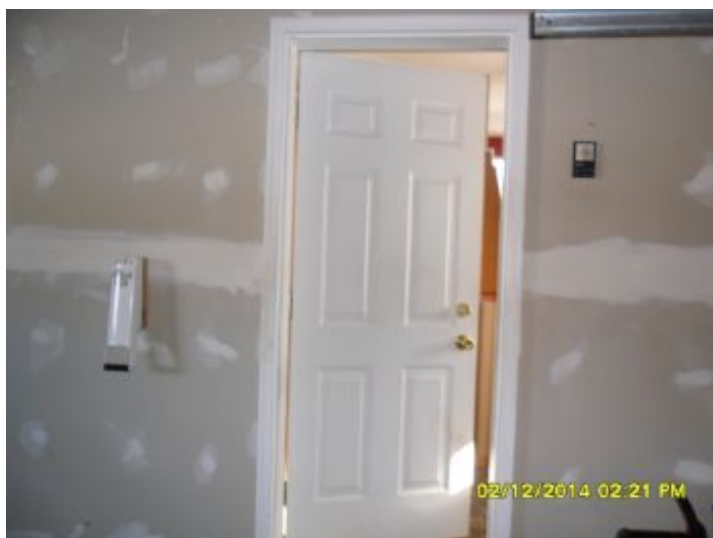
Garage-house door does not close automatically. This is to act as a fire stop, and keeps exhaust fumes out.

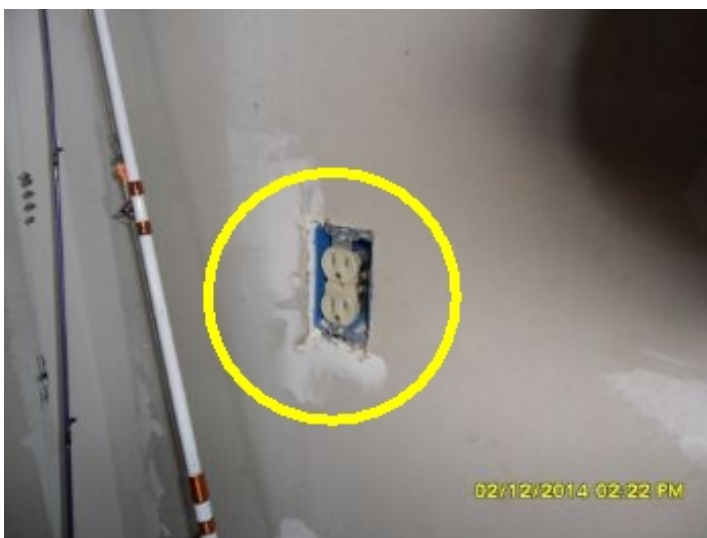
Electrical outlets and switches are missing covers. Recommend adding covers to reduce electrical hazard.

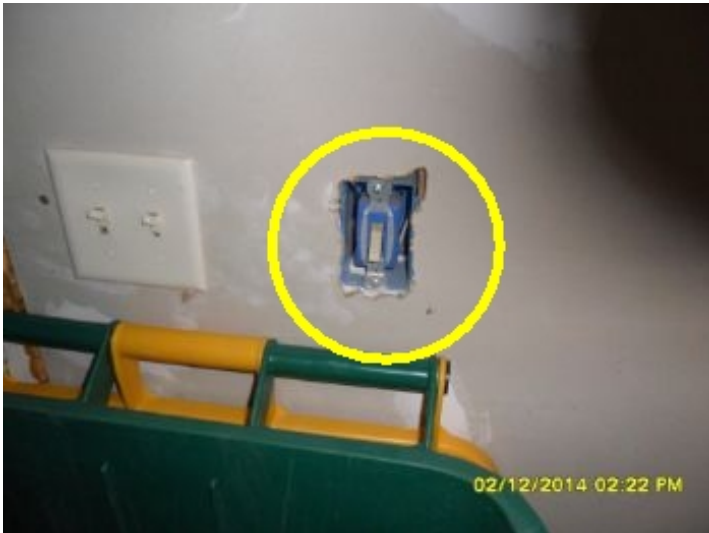
Electrical outlets and switches are missing covers. Recommend adding covers to reduce electrical hazard.

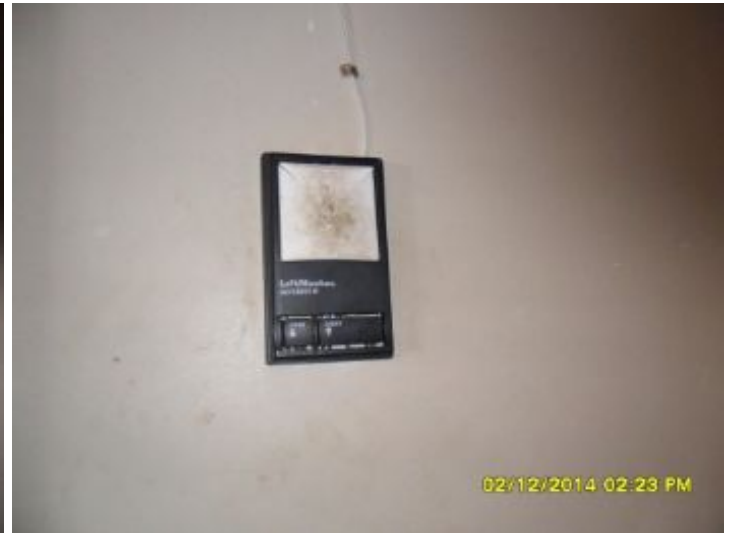
Garage vehicle door opener appears to be disconnected, damaged or otherwise inoperable. Have evaluated and repaired.

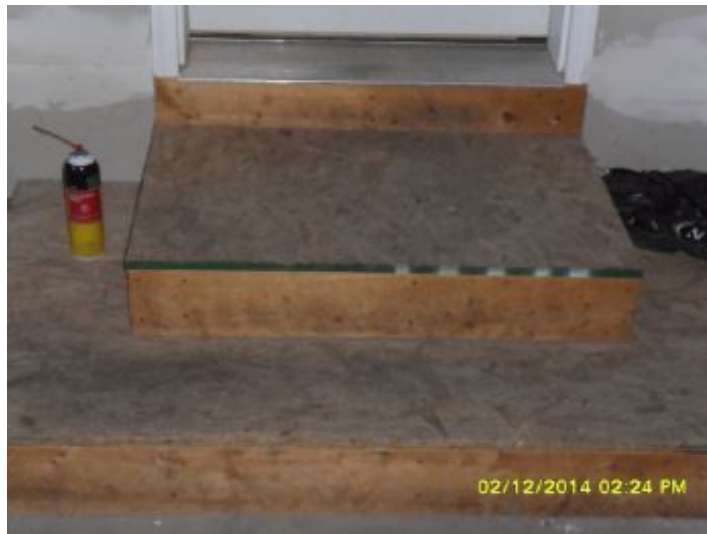
Garage-house entry steps are non-standard in height or depth. Possible trip hazard. Recommend steps replaced by licensed contractor.

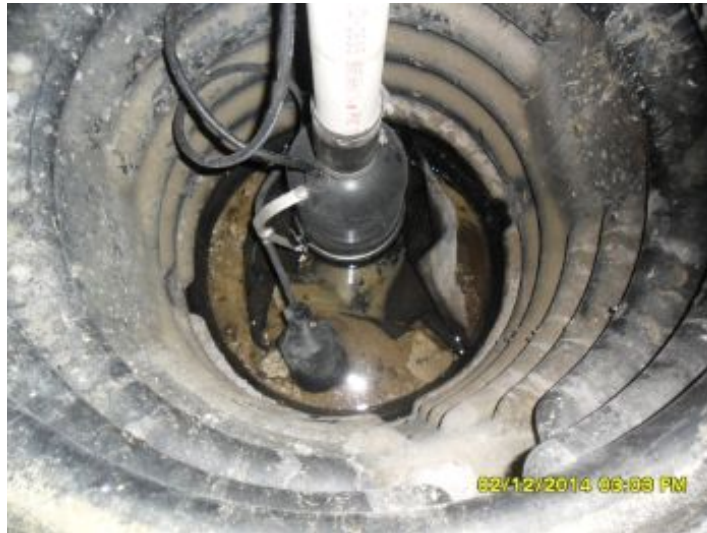
Sump pump does not appear to be installed properly.

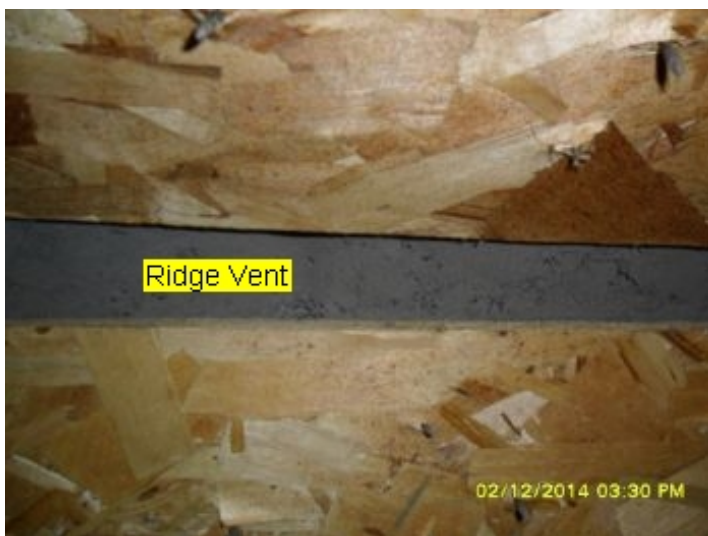
Ridge vent filter is plugged. This will cause the attic ventilation to be inefficient leading to moisture problems. Recommend replacement of ridge vent. Baffled ridge vent works the best in our climate.

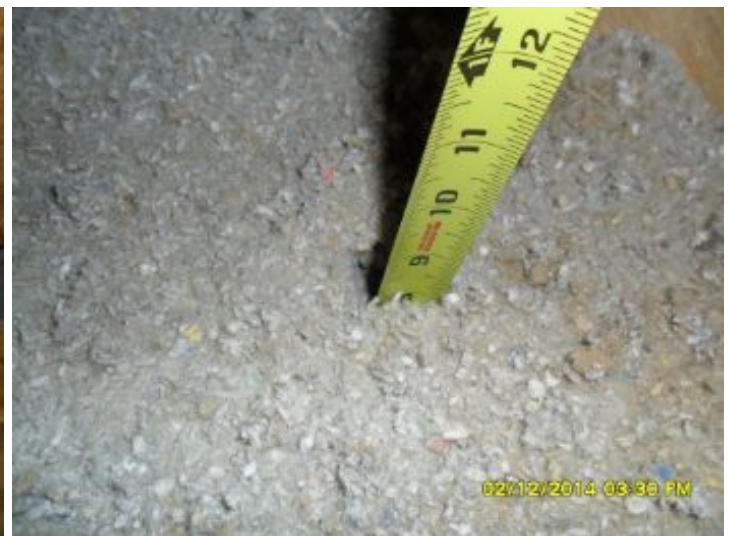
Insulation averages about 8-10 inches in depth, recommend adding an additional 10 inches for increased home efficiency.

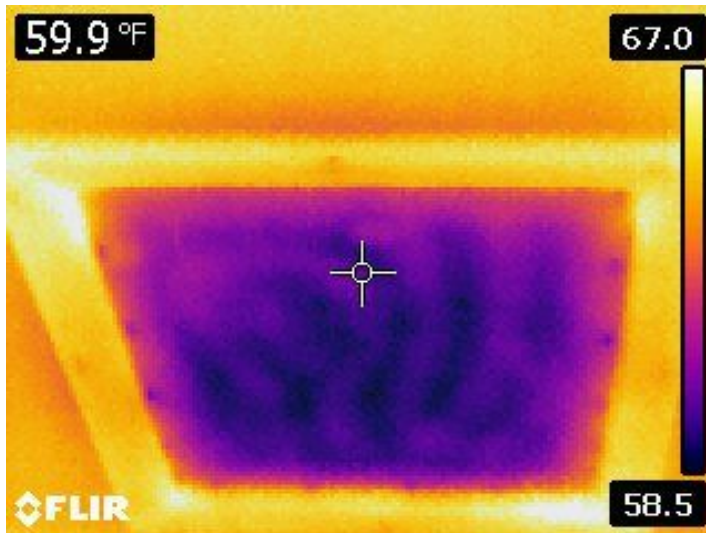
No insulation over attic hatch; recommend installation, then sealing hatch with caulk to minimize heat loss.

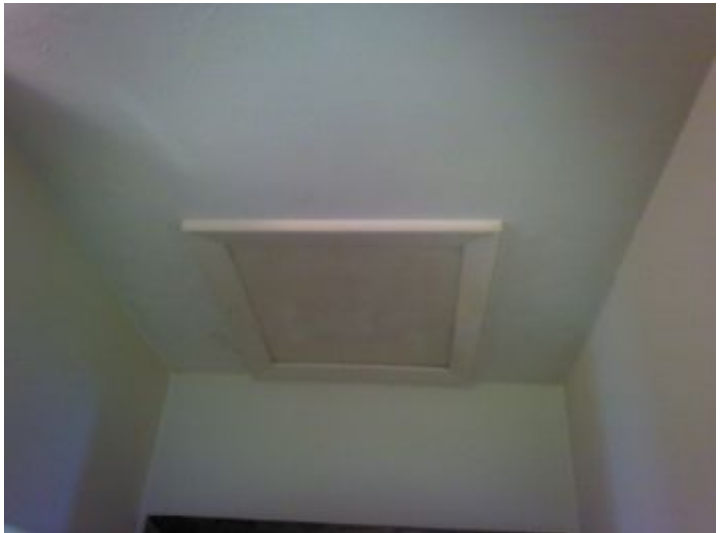
No insulation over attic hatch; recommend installation, then sealing hatch with caulk to minimize heat loss.

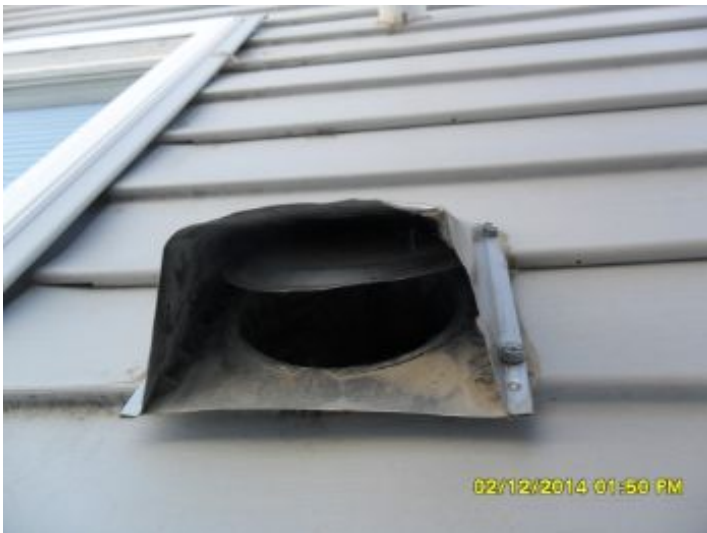
Dryer vent hood does not seal.

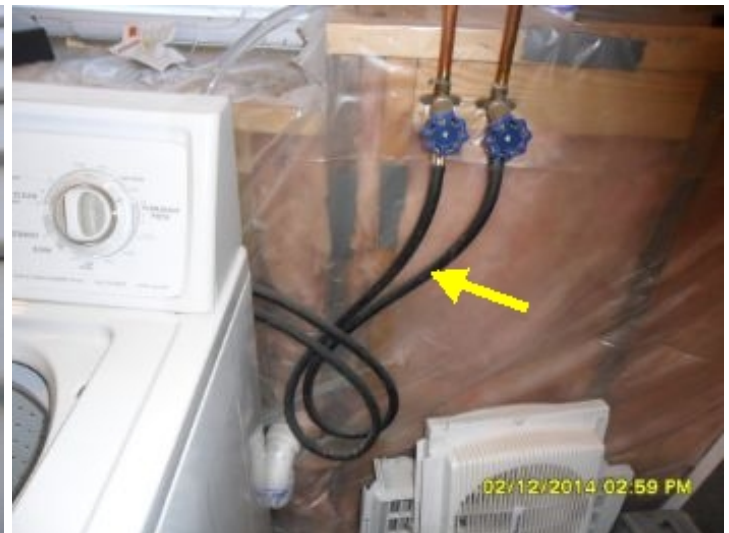
Washing machine supply line is rubber. Recommend replacing with braided stainless steel lines.

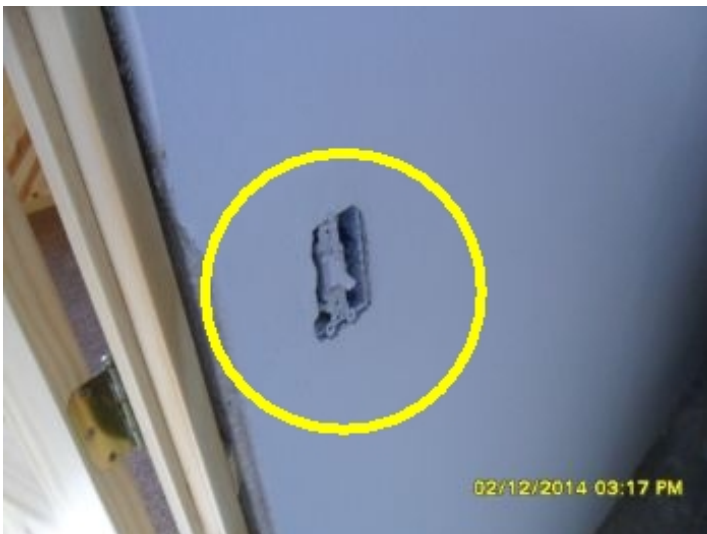
Light switch cover missing in basement

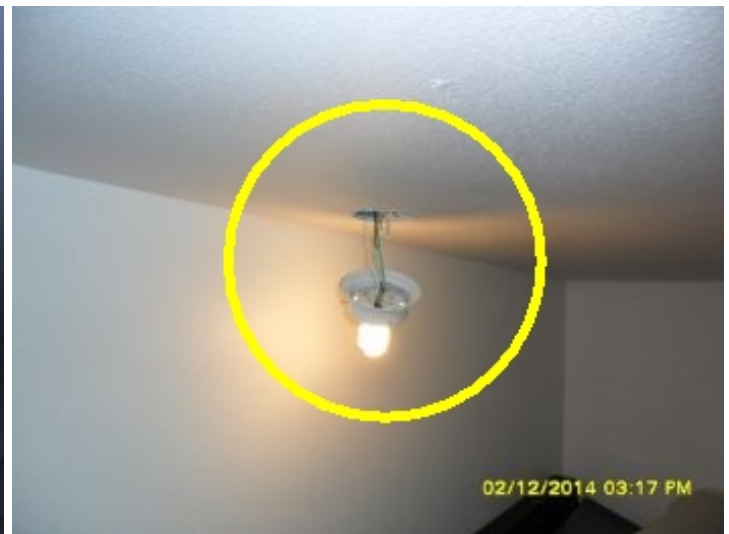
Light fixture loose from ceiling under stairwell.

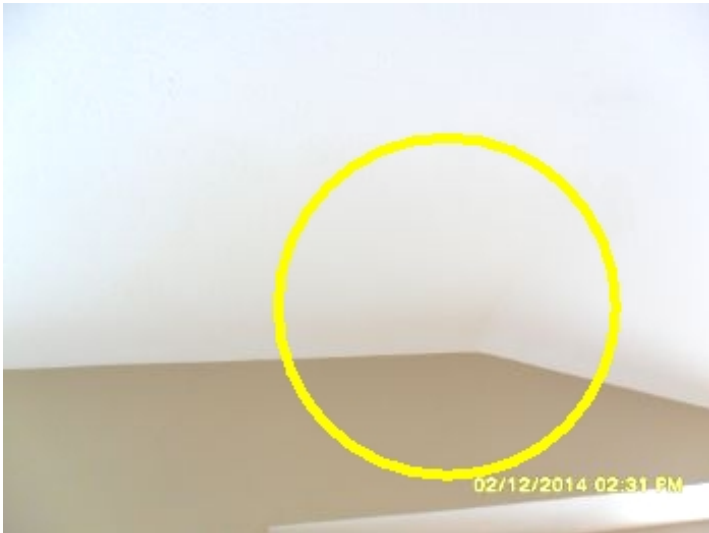
Fresh paint was observed. Although it improves the appearance, it may conceal any possible defects or prior repairs.

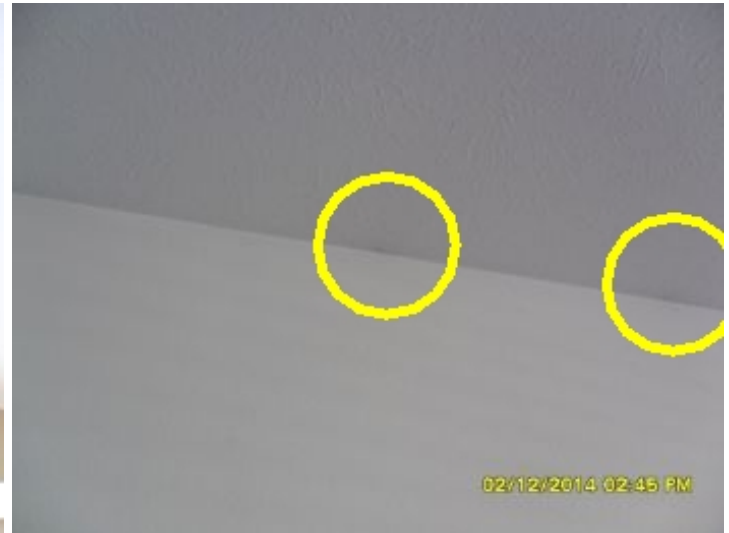
Possible water stains, dry at time of inspection.

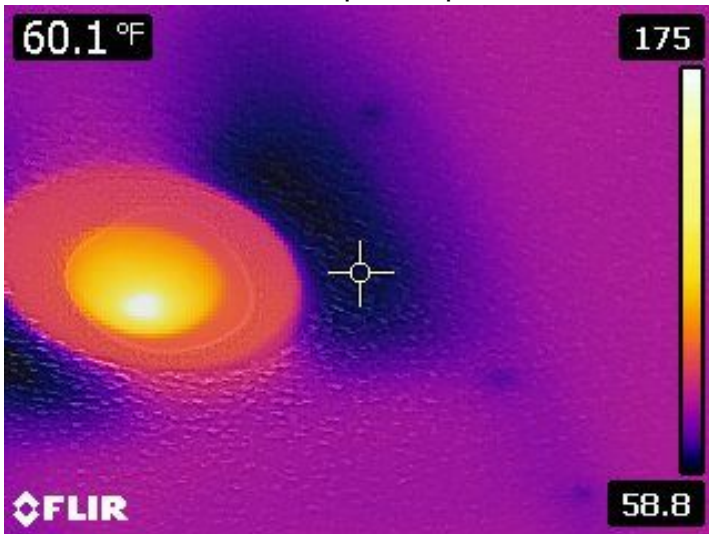
Cold spots around the cam lights.

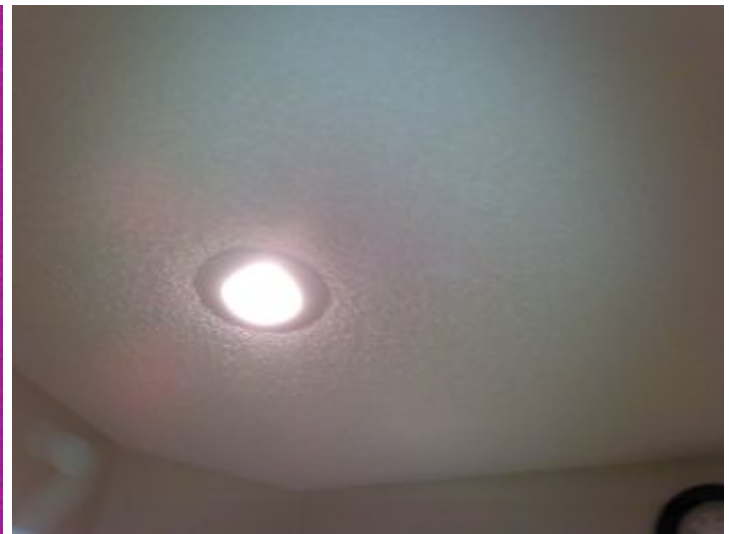
Cold spots around the cam lights.

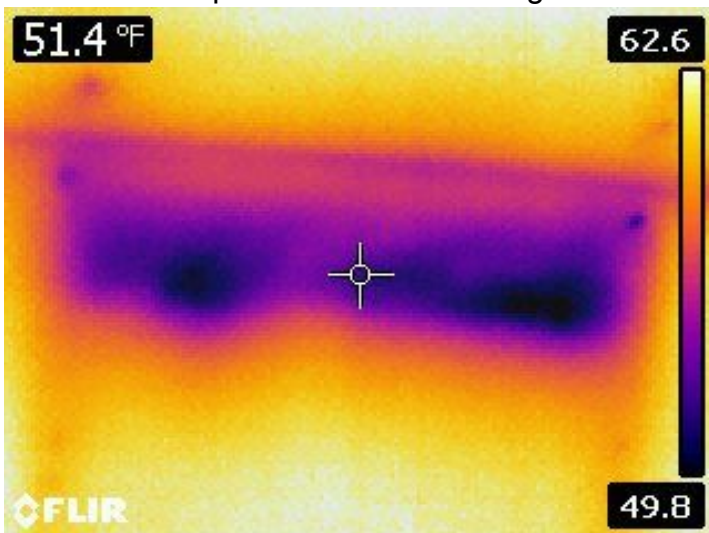
Cold spot in upstairs bedroom wall due to possible insulation missing on exterior wall

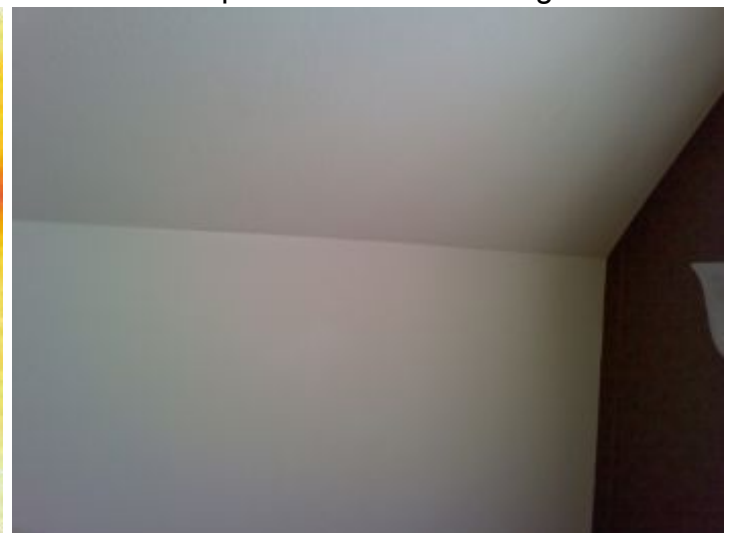
Cold spot in upstairs bedroom wall due to possible insulation missing on exterior wall

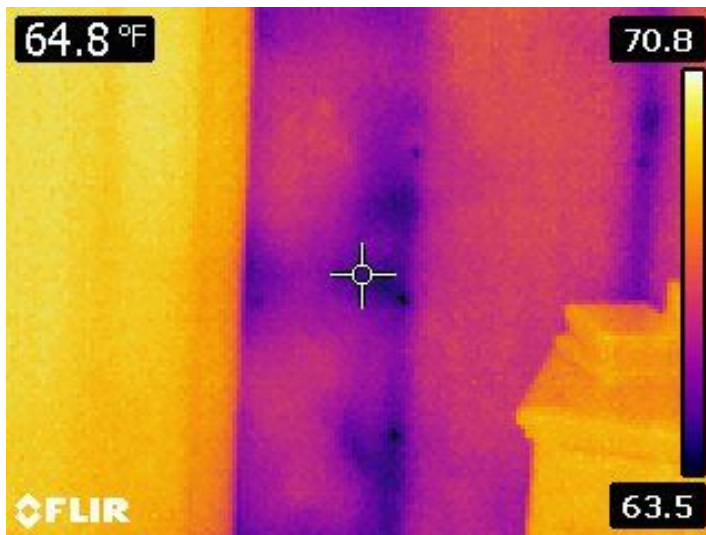
Cold spots in master bedroom wall may be caused by improper insulation techniques.

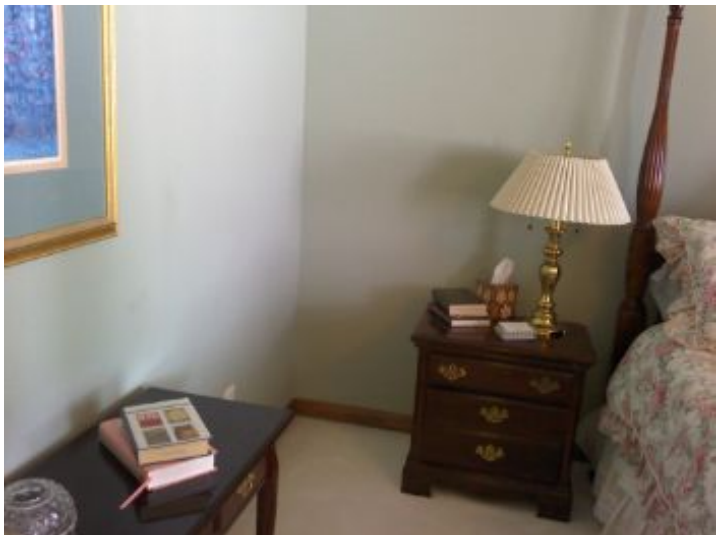
Cold spots in master bedroom wall may be caused by improper insulation techniques.

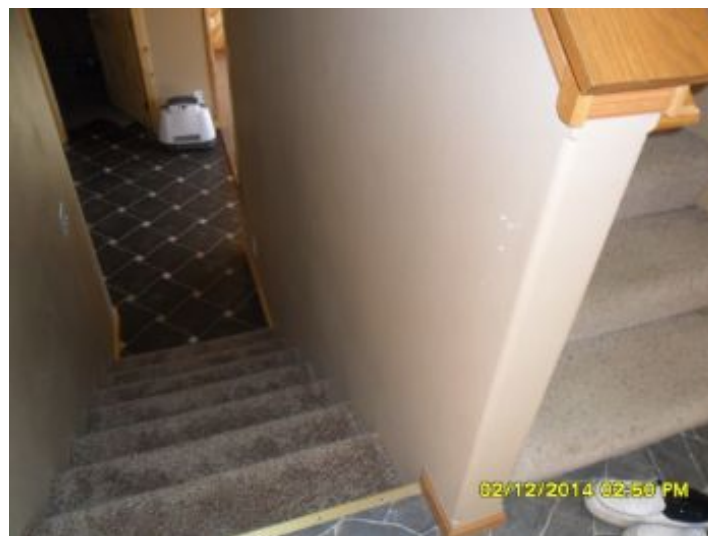
Hand Rail Components missing at basement stairwell. It appears to have been removed, but hand rail is present.
